FRENCH CREEK INSPECTIONS

## NEW/WARRANTY RESIDENTIAL HOME INSPECTION

1234 Main Street  
Raleigh, NC 27614

01/04/2024 9:00AM

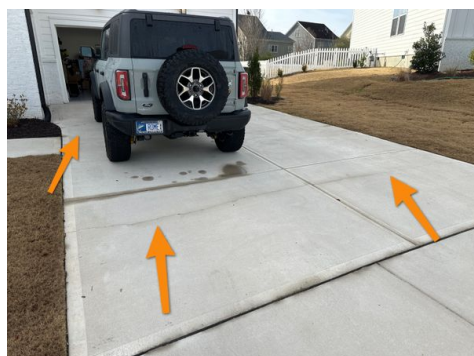
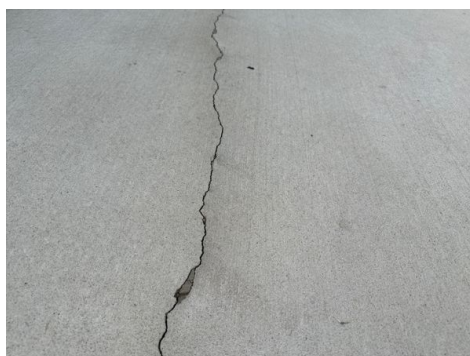
DRIVEWAY

**CRACKED**

Condition: The driveway is cracked with little opening or displacement.

Implication: Continued water infiltration will cause more damage.

Recommendation: Refer to the builder for repair.

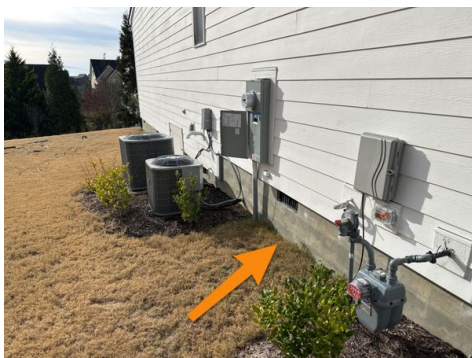
Left

**BLOCK: PARGE CRACK**

Condition: Cracks on the exterior of the foundation appear to extend only through the parge coat - a decorative coating of the foundation block. Cracks were not visible on the interior of the foundation wall.

Implication: Foundation cracks can be indications of differential movement - a structural concern, but this crack does not extend through to the interior.

Recommendation: Refer to the builder for further evaluation and, if necessary, repair.

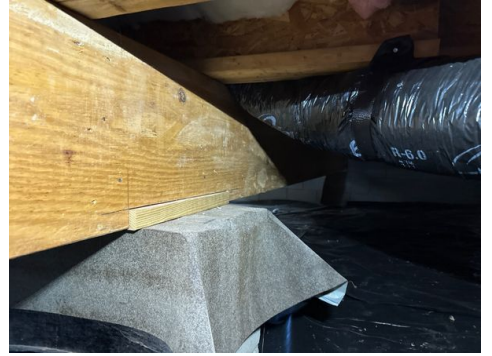
Concern

**BEAM: COMPOSITE CUT/NOTCHED**

THROUGHOUT, PLEASE CHECK ALL

Condition: Composite floor beams are cut or notched.

Recommendation: Refer to the builder's engineer for further evaluation and, if necessary, to prescribe repairs.

Note: Records of the engineer's findings and the builder's repairs should be maintained to support future sale.

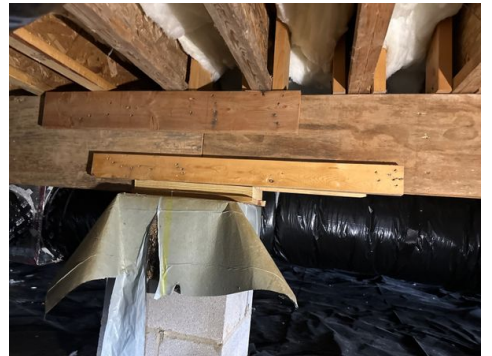
Concern

**BEAM: REPAIR**

CENTER REAR

Condition: A girder or beam previously reported as heavily notched has been repaired with "sistered" pieces of lumber.

Implication: The girder/beam is a structural component that supports the floor framing and transfers loads to the foundation system. Structural repairs should be prescribed by an engineer and carried out by a licensed general contractor according to the direction of the engineer.

Recommendation: Request documentation that ensures all structural repairs were prescribed by the builder's engineer. If not available, refer to the builder's engineer for further evaluation and, if necessary, to prescribe repair.

Note: Records of the engineer's recommendations and the builder's repairs should be maintained to support future sale.

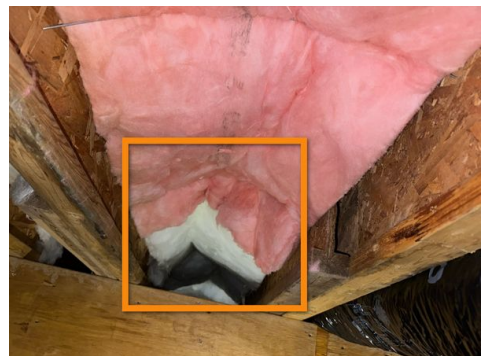
Concern

**I-JOIST: BLOCKING MISSING**

FRONT AND REAR GIRDERS

Condition: The space between I-Joists where section ends overlap over a structural girder are not "blocked".

Recommendation: Refer to the builder to confirm the flooring system is built as designed and blocking is not required.

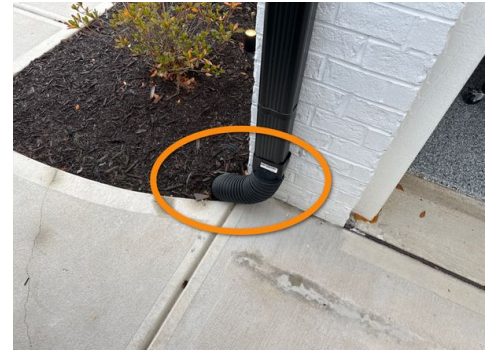
Condition: The gutter downspouts are piped underground. The exits of these pipes were not located or verified.

Implication: Direct drainage from the gutter system can result in water penetration into the foundation area and foundation deterioration.

Recommendation: Refer to the builder to locate the outlet ends including that of any surface drains. The underground piping should be routinely flushed to ensure it flows freely and, if necessary, repaired.

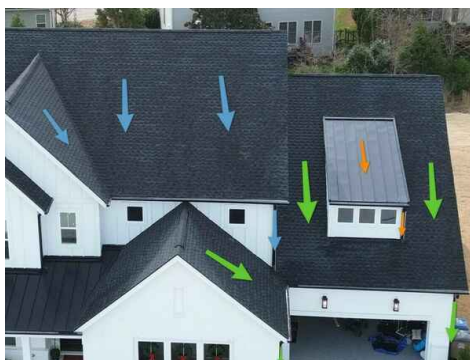
Condition: Large roofs and gutters drain onto other roofs and/or into small section(s) of gutter/downspout. Evidence of overflow suggests the concentration of water volume is overwhelming the system during heavy rain.

Implication: The concentration of flow has overwhelmed gutters and downspouts. Direct drainage from the gutter system can lead to water penetration into and deterioration of the foundation or underlying wall structure.

Flow to Garage Downspouts

Recommendation: Ask the builder to remediate.

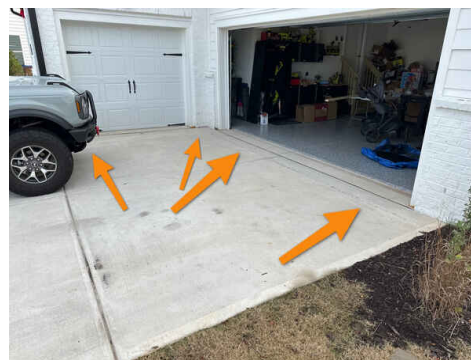
Surface Abrasion

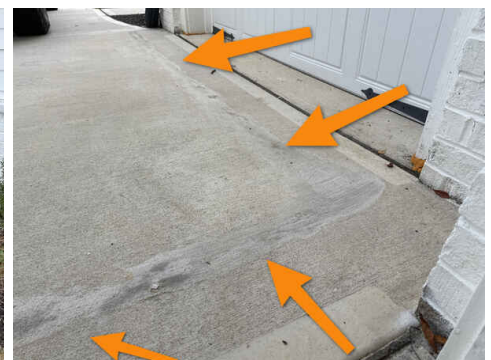
Surface Abrasion

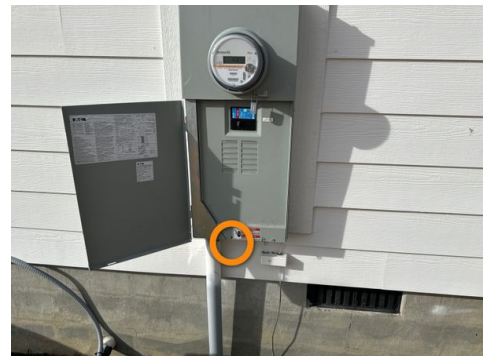
#### **FASTENERS: MISSING**

Condition: The cover of an electrical panelboard is held in place with an insufficient number or incorrect type of fastener(s).

Implication: The cover must be secured with the correct type, size and number of fasteners to prevent direct contact with electrical circuits and contain energy released in the event of a short or explosion.

Recommendation: Refer to to the builder for further evaluation of the entire electrical system and remediation as necessary to deem it safe.

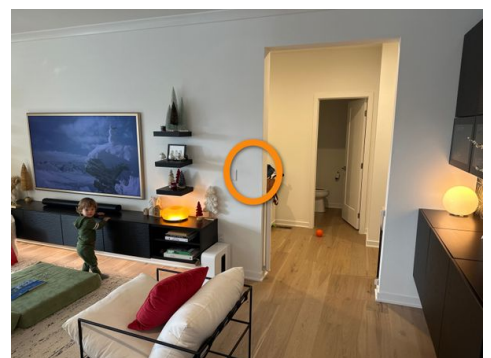
Family

#### **LIGHT: ROOM SWITCH ACCESS**

Condition: A room light fixture is not operated by a switch from all entrances to the room.

Implication: For safe access, lights should be controlled from all points of access.

Recommendation: Refer to the builder for repair.

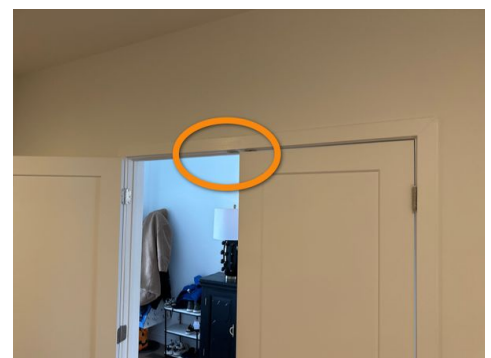
Office

Condition: The door latch assembly of an interior door(s) is not aligned with its opposing striker.

Recommendation: Refer to the builder for repair.

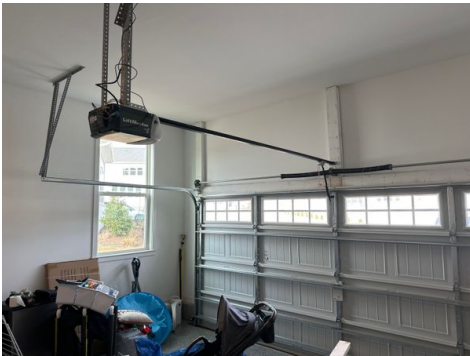
Right

Condition: The garage door operator does not automatically reverse or stop when meeting a reasonable resistance during closing.

Implication: The ability to reverse or at least stop when meeting a reasonable resistance is important to the safe enjoyment of the garage door.

Recommendation: Refer to the builder for repair.
