FRENCH CREEK INSPECTIONS

## NEW/WARRANTY RESIDENTIAL HOME INSPECTION

1234 Main Street  
Raleigh, NC 27614

01/04/2024 9:00AM

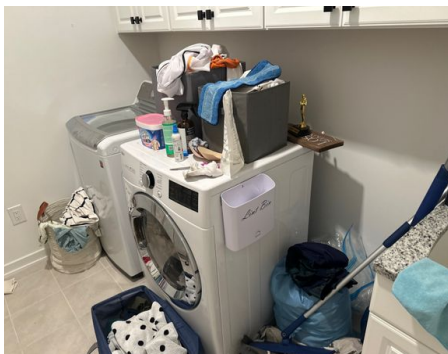
Advisory: Inspection of laundry appliances are outside the scope of the NC standard of practice. Refer to an appliance specialist to assess any appliances included in the purchase of the home.

If not already present, burst-resistant hoses should be installed after purchase to reduce the chance of a hose failure and damage to the underlying structure. A washing machine leak detection system that will turn off the water supply is also worth considering. Refer to an appliance installation specialist for more options.

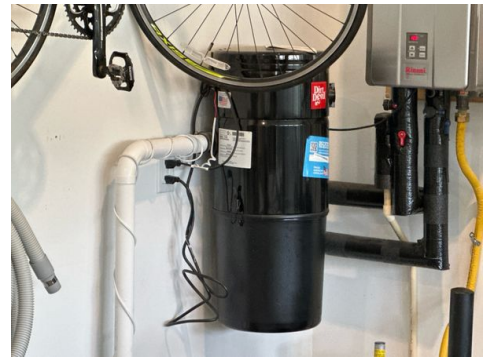
**CENTRAL VACUUM NOT SOP**

Limitation: Per the NC Standards of Practice, central vacuum systems are not inspected. Refer to a specialist if evaluation prior to purchase is desired.

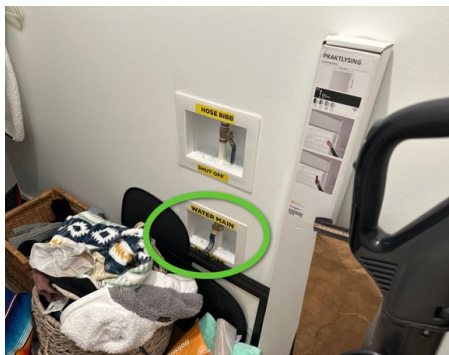
Advisory: In case of a plumbing related emergency, it is important that family members know where the main plumbing shutoff valve is located. A second valve used to stop water flow to the exterior faucets (aka "hose bibs") may be located in the same area. When closed, this valve allows you drain the exterior faucets and prevent them from damage due to unusual cold.

Note: The valve is not tested.

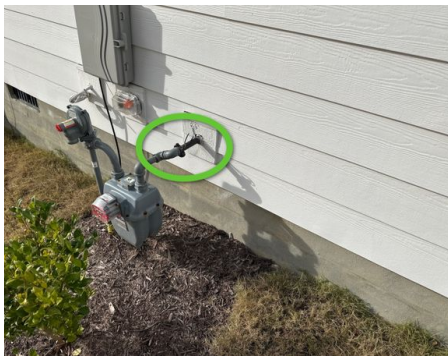
Bond

Advisory: Corrugated stainless steel (CSST) piping is used to transport natural or propane gas throughout the home. This type of gas line requires installation without exceeding bend radius allowances, support, protection and electrical bonding to the house electrical ground. The bonding is designed to reduce the probability of lightning related electrical arcing which can perforate the tubing and cause gas leakage/fire. During the home inspection the bonding attachment **WAS found** at the gas meter **as expected**. This is **NOT a defect**, but it is important that this bond is maintained and inspected regularly for corrosion.

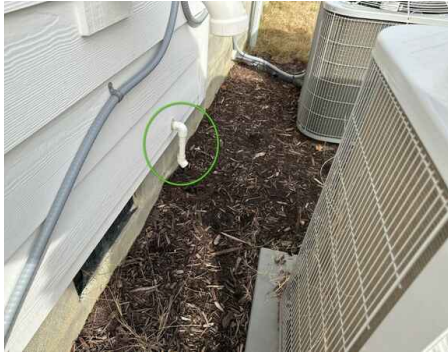
### Heating Equipment: Advisory: High Efficiency Gas Furnace

Advisory: High efficiency gas furnaces recirculate the products of combustion through a secondary coil to add more heat to the home. As a result, the temperature of flue gases are brought below the "dew point" causing these systems to produce condensation while operating. This condensation is drained away from the home in the same fashion as with the cooling cycle and must be maintained to avoid damage to the system components. Diligent observation is required during especially cold weather. If the outlet freezes, water will backup into the unit, causing the unit to shut down and possibly damaging the cabinet.

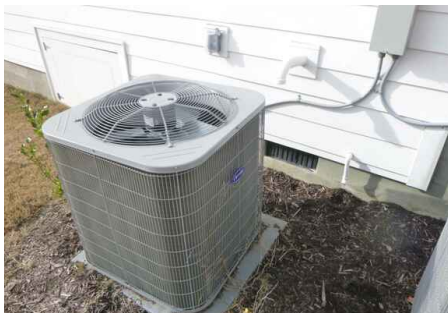
### Cooling Equipment: Advisory: Vegetation

Advisory: While it is not an issue today, landscaping around the HVAC unit will eventually encroach on the unit and block air flow. Proper clearance is required to ensure airflow and efficient operation. Keep vegetation trimmed away from the HVAC unit.

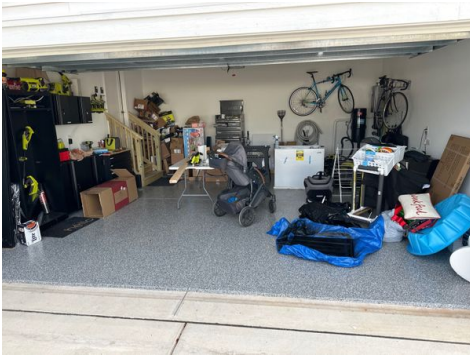
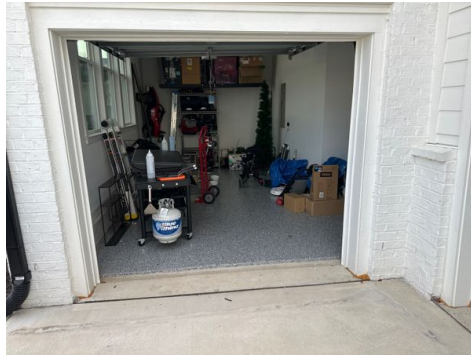
Limitation: Inspection of the garage floor, walls and foundation was greatly impaired by the storage of personal items.
